Conservation and management of modern historic buildings: Recent works on heritage of Portuguese origin

Paulo B. Lourenço

**Why are good technical
skills needed for existing
structures?**

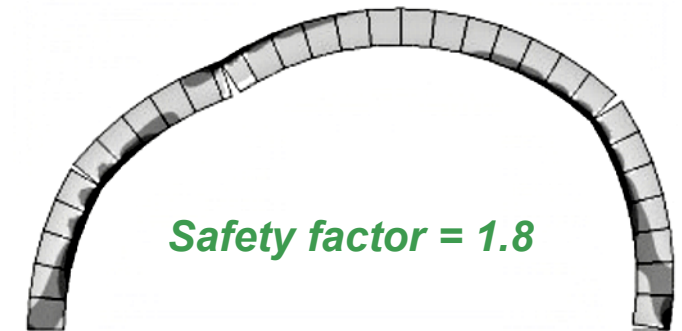
Good designer
(nonlinear, $f_t = 0.2 \text{ N/mm}^2$)

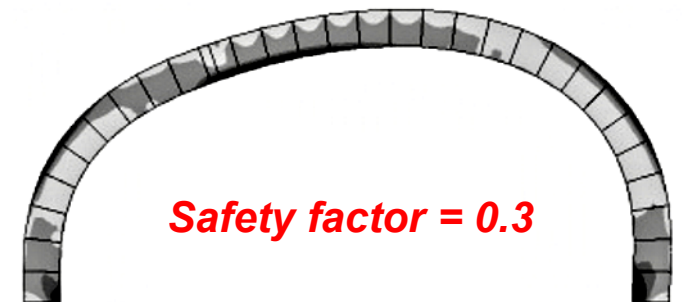
Bad designer
(elastic, $f_t = 0.2 \text{ N/mm}^2$)

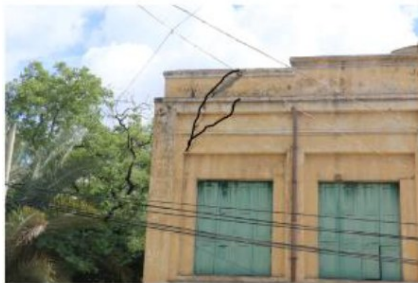
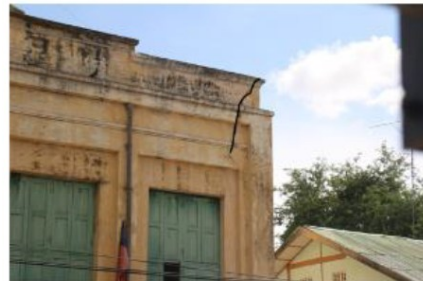
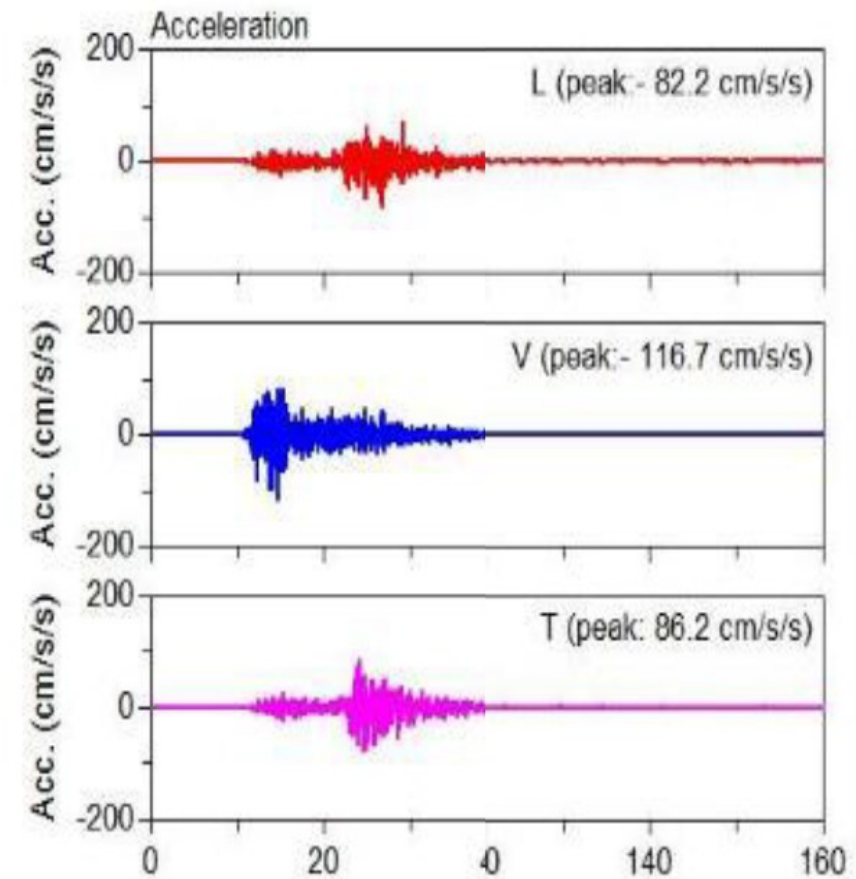
Example 1: Bagan, Myanmar (2016 Earthquake)

- ❑ Strong vertical component
- ❑ Minor damage
- ❑ 4 people killed

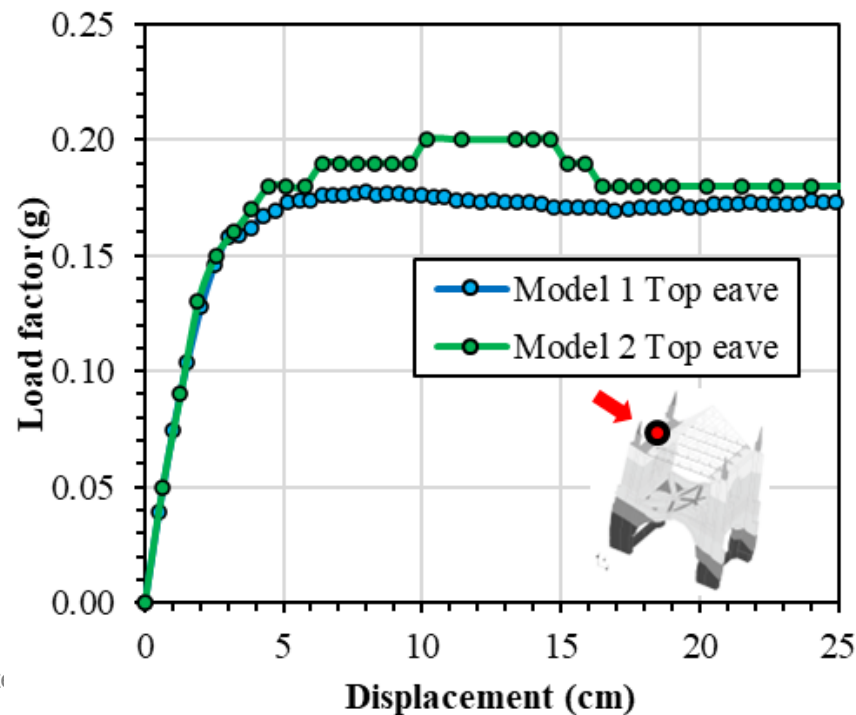
Lateral displacement: 25cm
Load-factor 0.17276
Total Strains E1 maximum of 5 layers
min: -8.78e-03 max: 2.16e-01

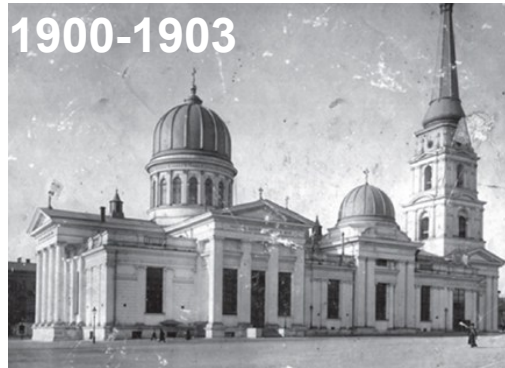
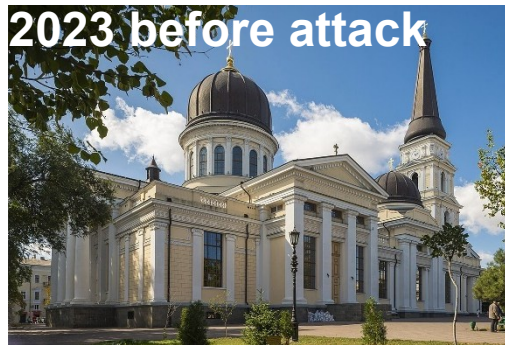
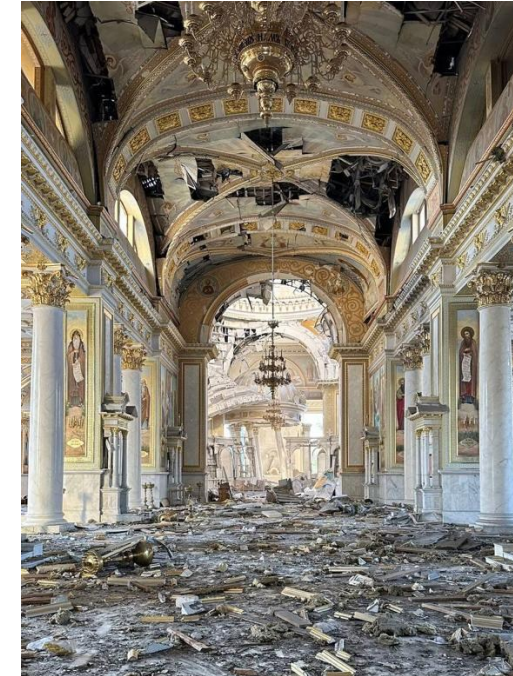
Example 3: Transfiguration Cathedral in Odesa, Ukraine

- ❑ Largest cathedral in the northwestern Black Sea region
- ❑ Demolished 1936 (Soviet struggle against organized religions). Rebuilt 2010
- ❑ Night July 22nd, 2023, hit by a missile

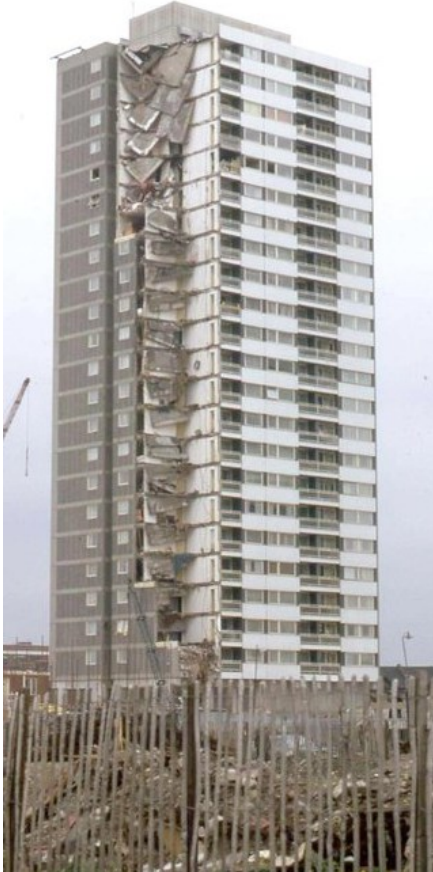
Ronan Point, 1968
Disproportionate collapse

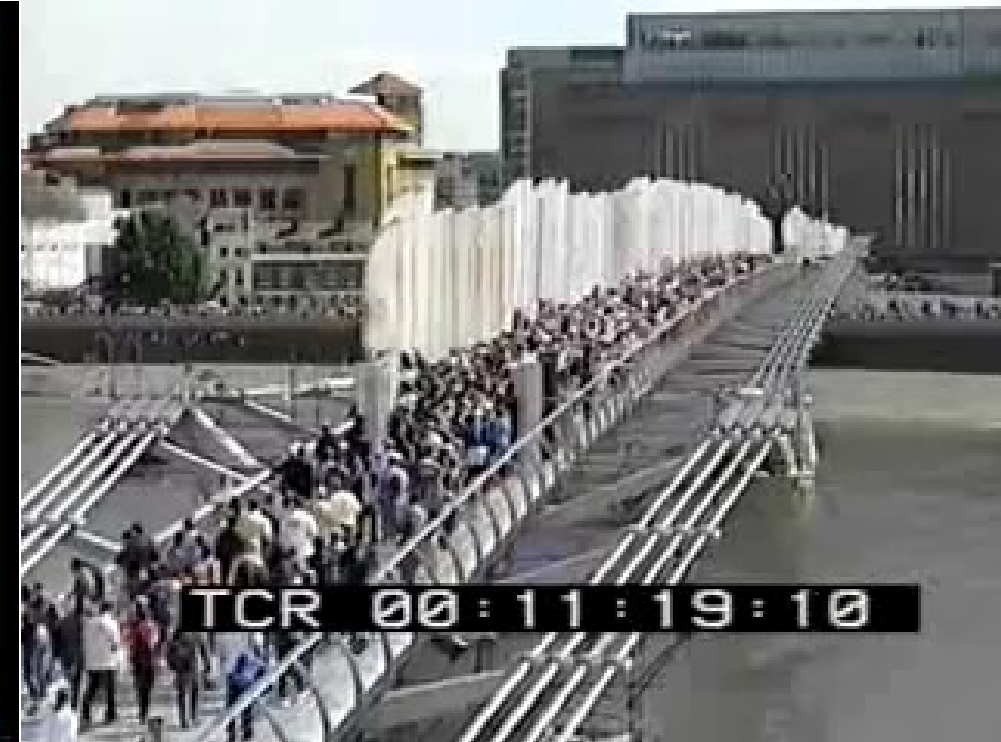
Millennium Bridge, 2020
Lateral frequency modes

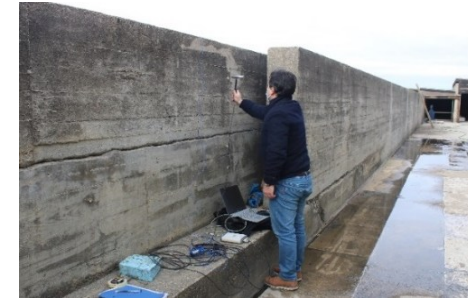
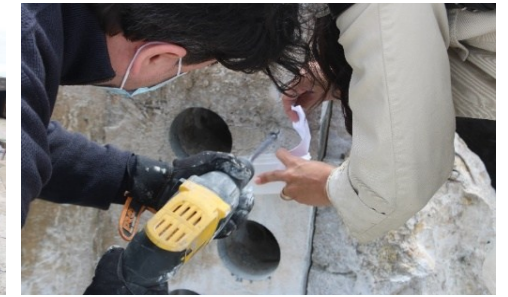
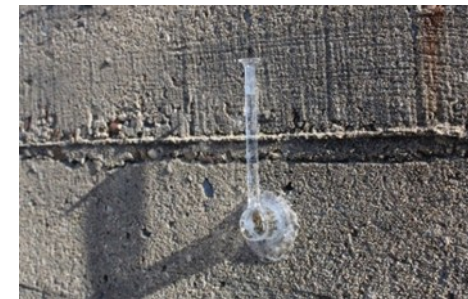
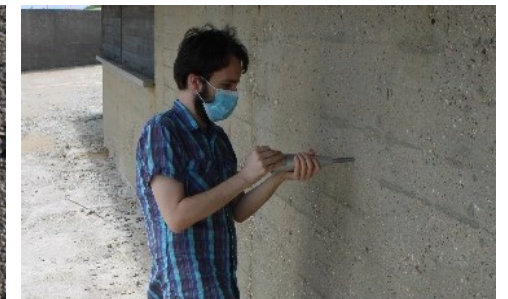
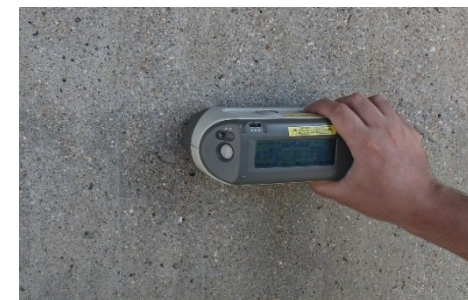
Non-destructive testing: Sonic, chloride content, water penetration, Schmidt hammer, color

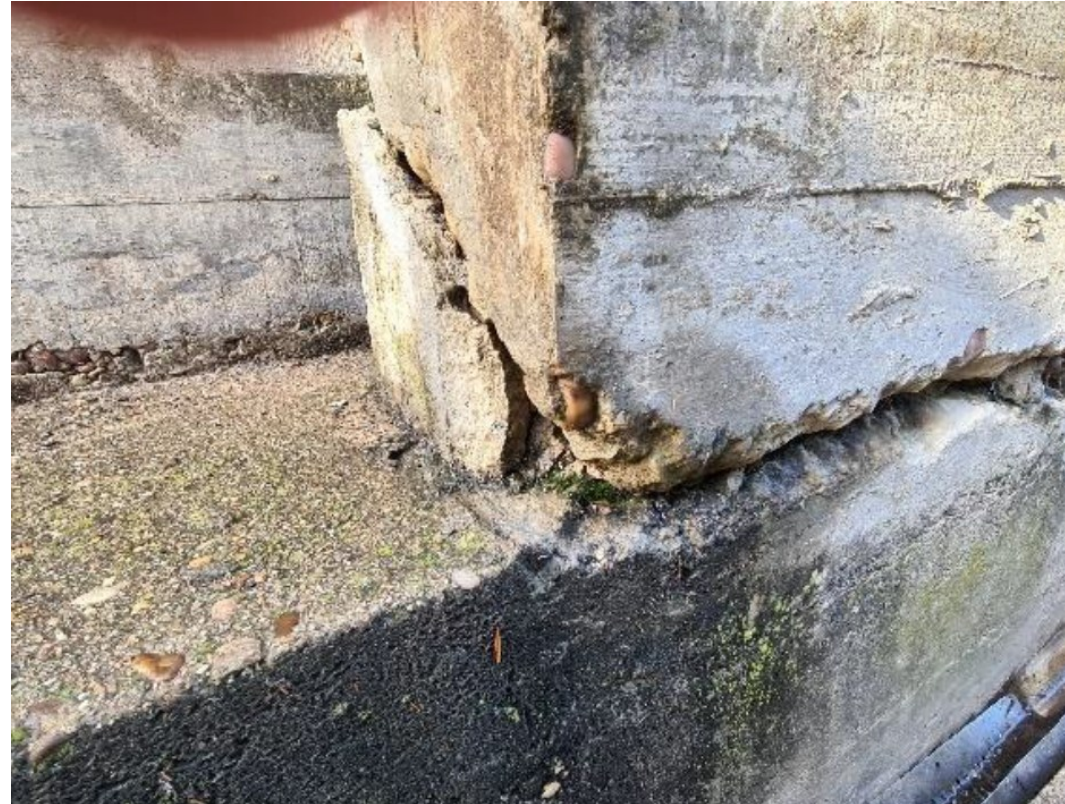
**Large volume loss and shrinkage /
thermal movement**

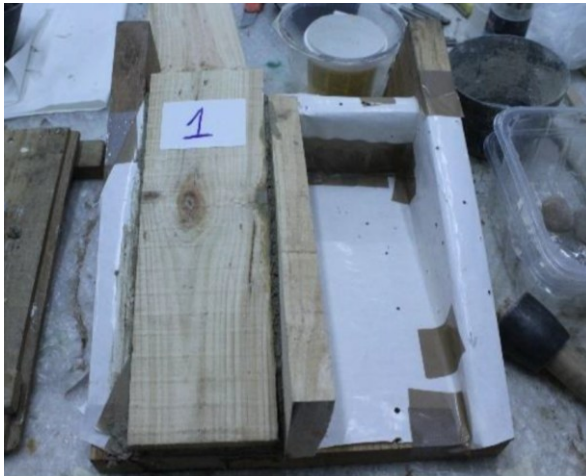
Wooden molds

**Replicating original
formwork**

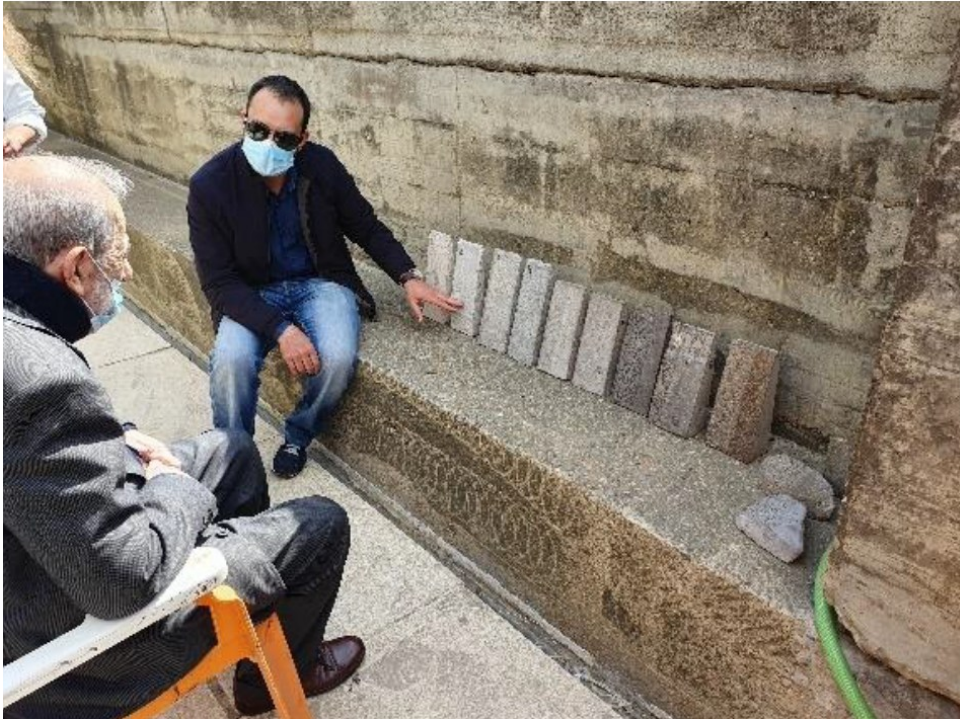
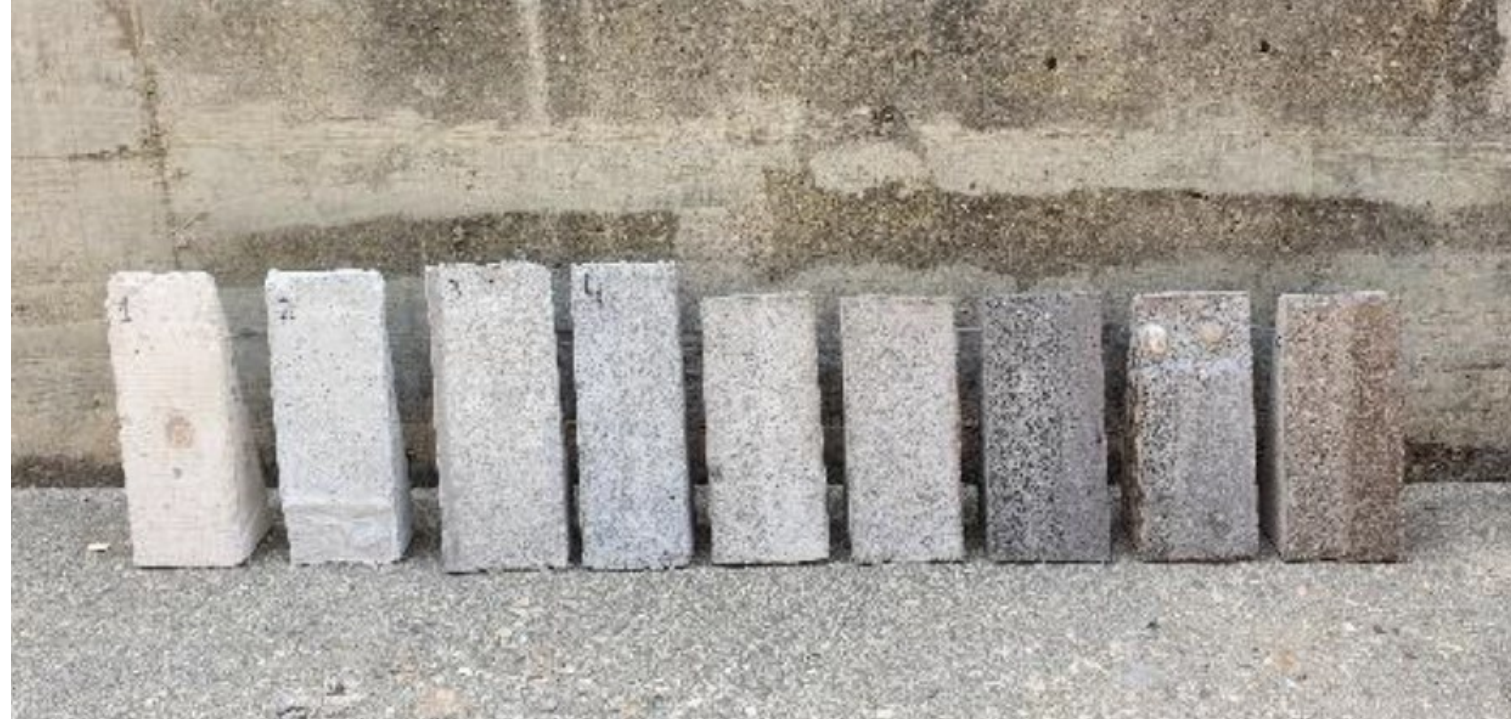
Materials: Sand, gravel, yellow granite powder, black limestone powder, pigments, natural cement and regular cement

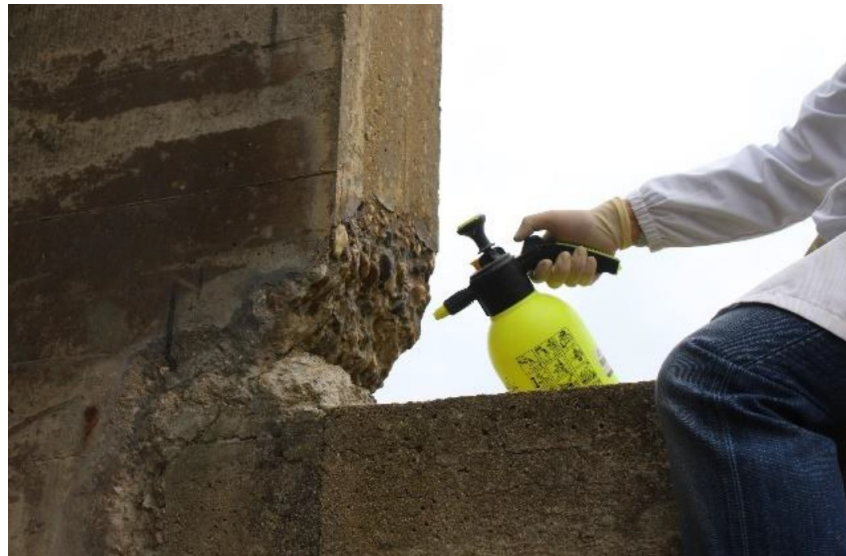
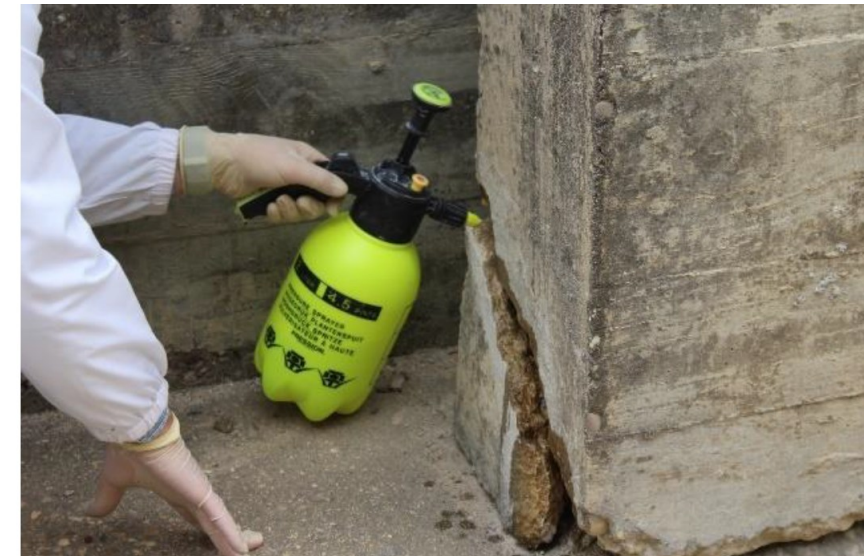
Cleaning and biocide

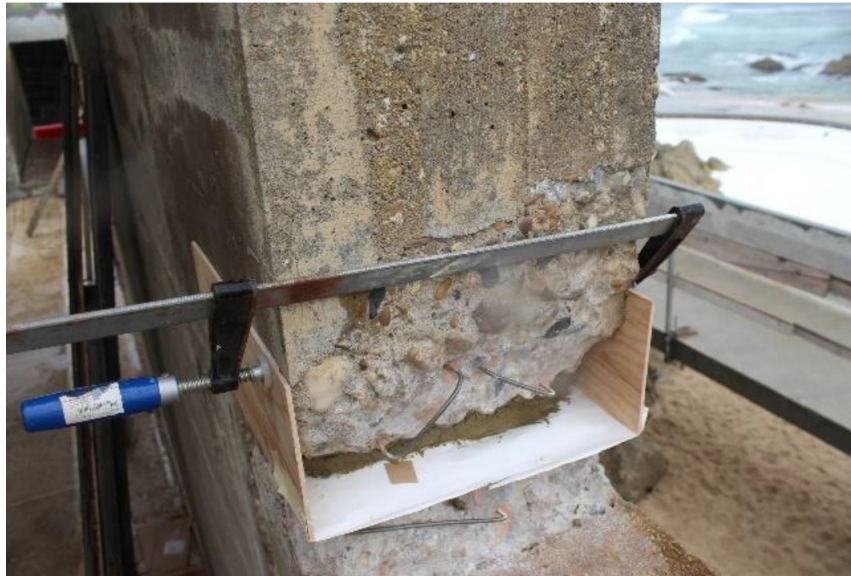
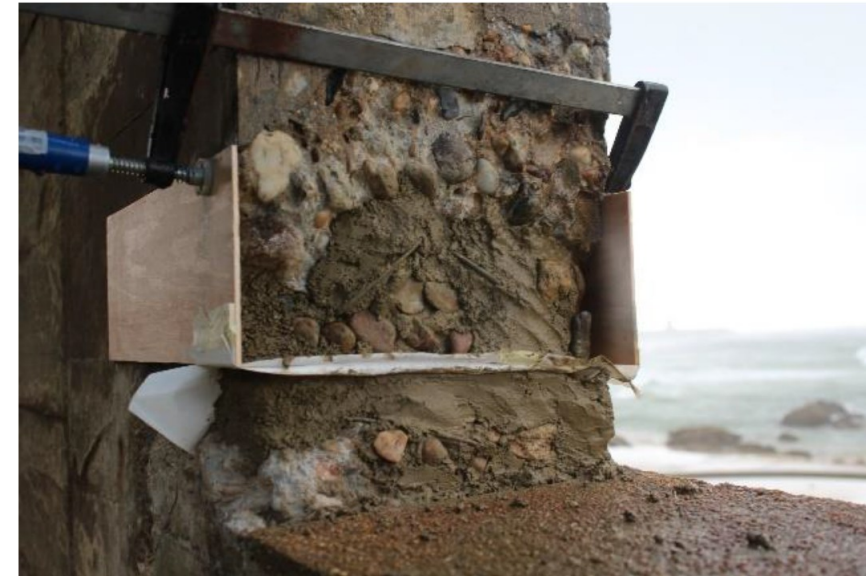
Stainless steel installation

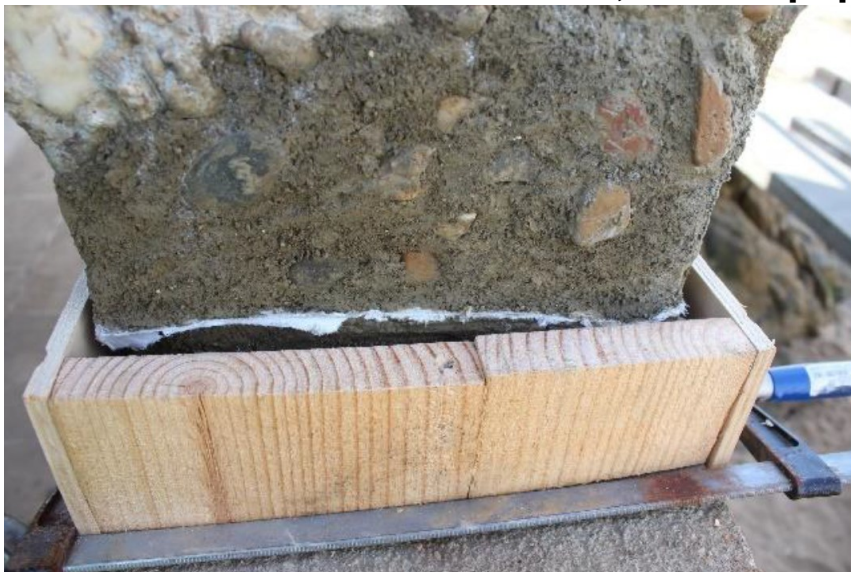
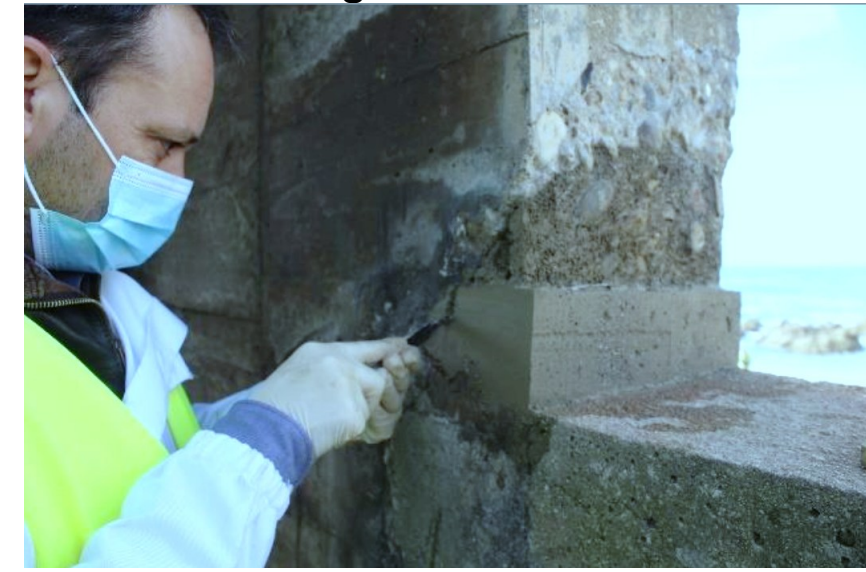
Mold, silicon paper and mortar filling

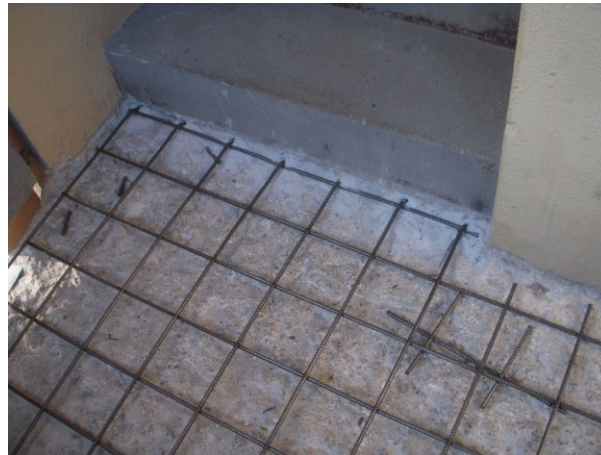
Staircase (go down)

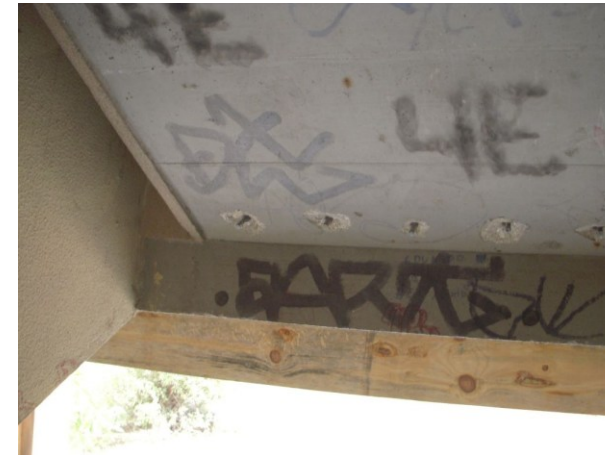
Staircase (go up): Upper view

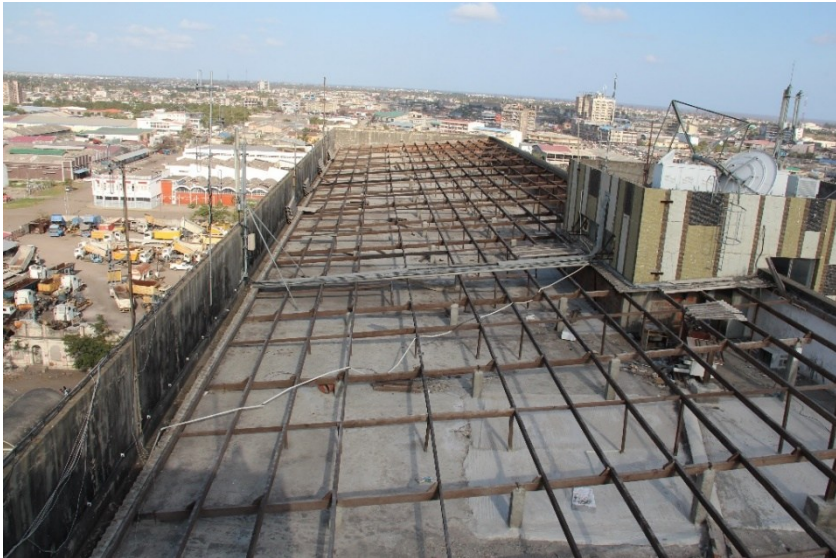
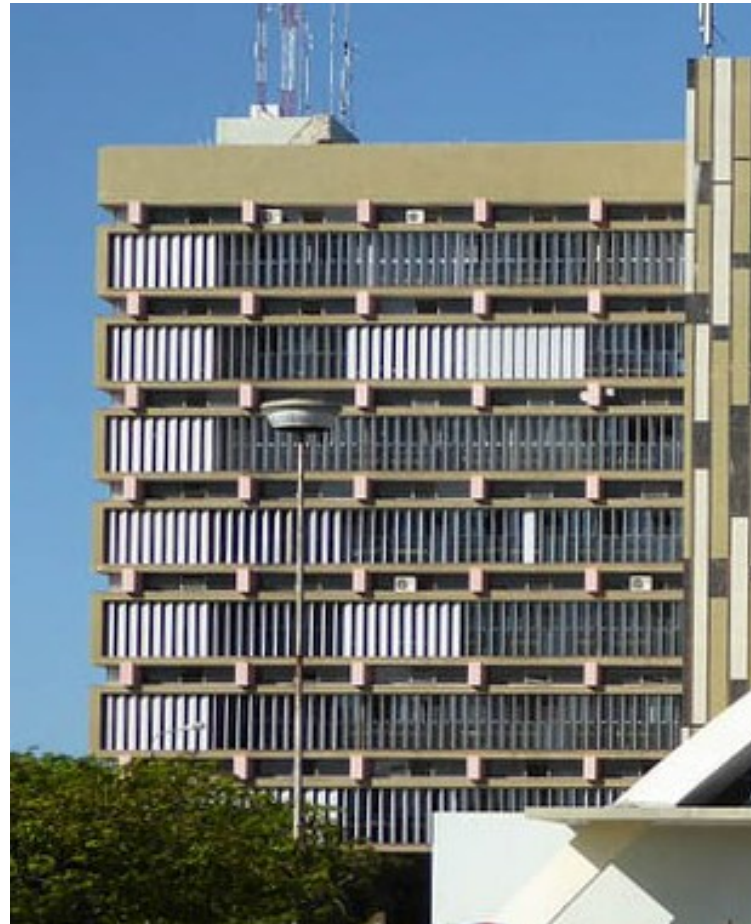
Damage 2019

- ❑ Plenty of water ingress
- ❑ Loss of roof
- ❑ Damage to facade elements (windows and shading)

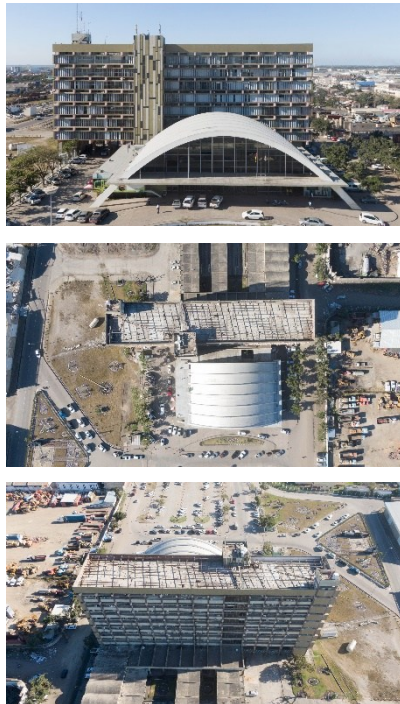
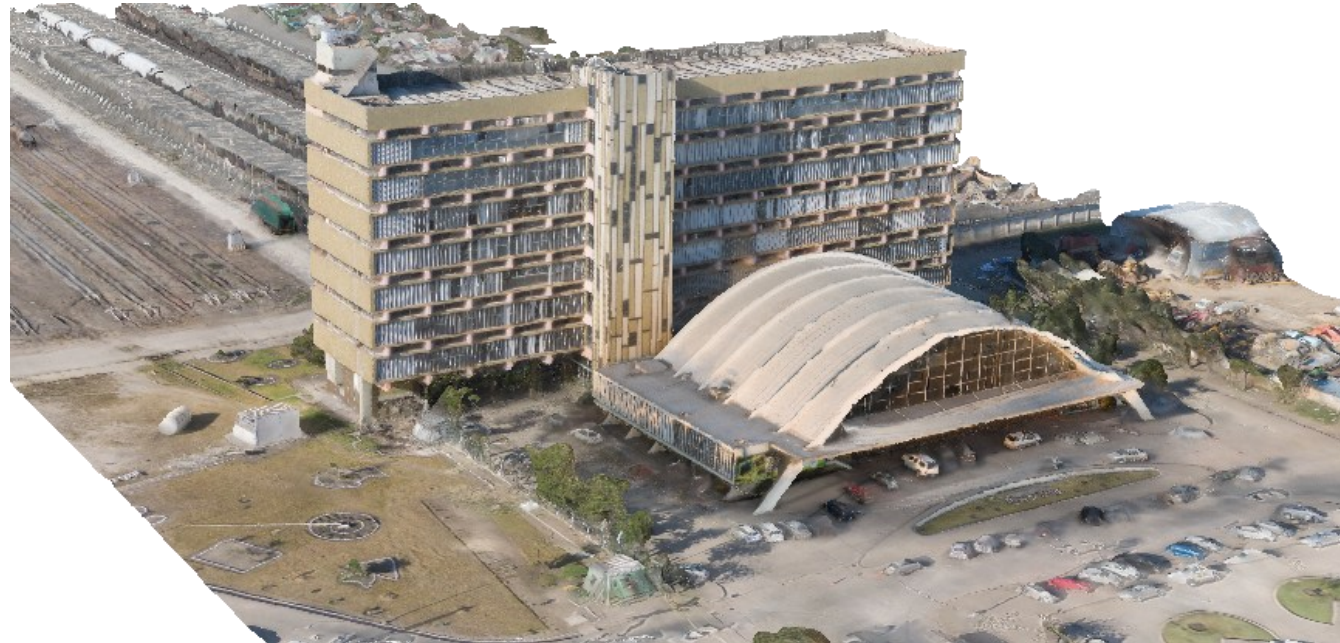
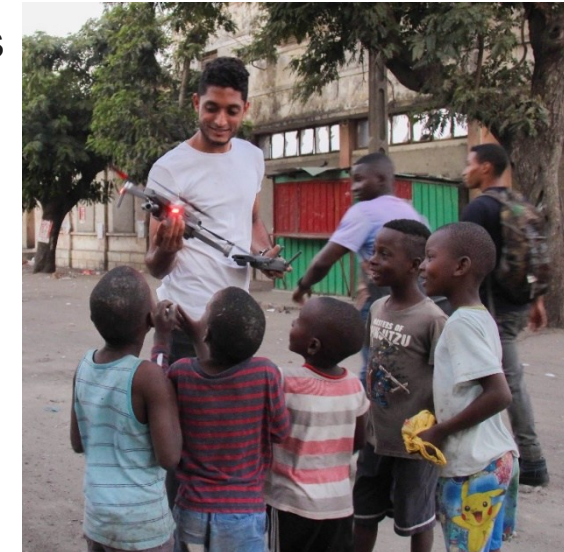
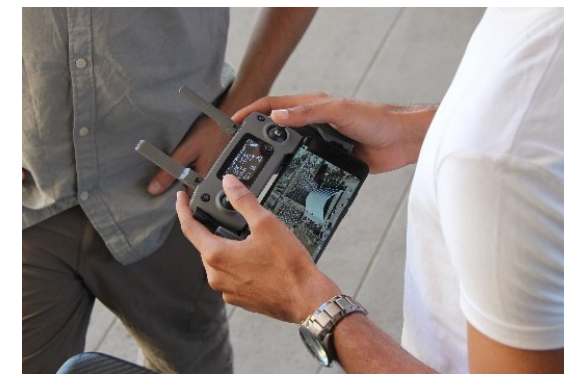
Drone survey and photogrammetry

- ❑ Graphic documentation of the current state of the building with photos and videos
- ❑ Creating a photogrammetric model using the flight photos

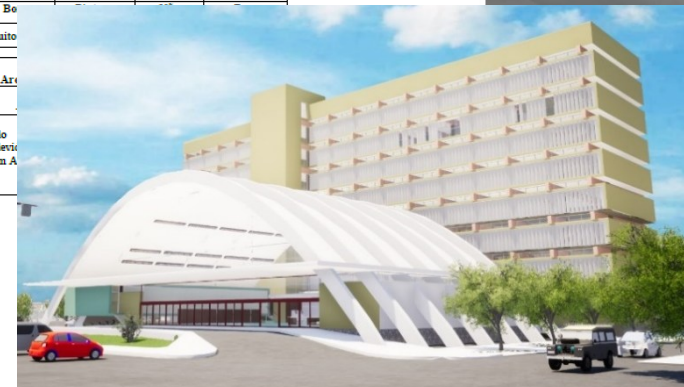
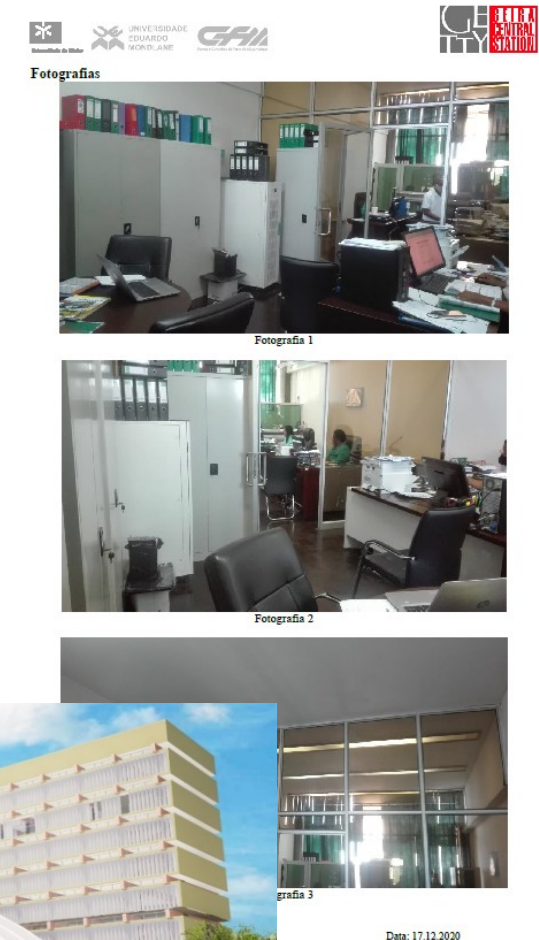
Ficha de caracterização: Espaço S.4.15

- ❑ Preparation of new plans of the current state of the building
- ❑ Plans include identification of uses of the different spaces (functional survey of the building)
- ❑ A BIM model was considered the most adequate approach, including material and construction details
- ❑ Database with information about material, architectural and functional characteristics of each space

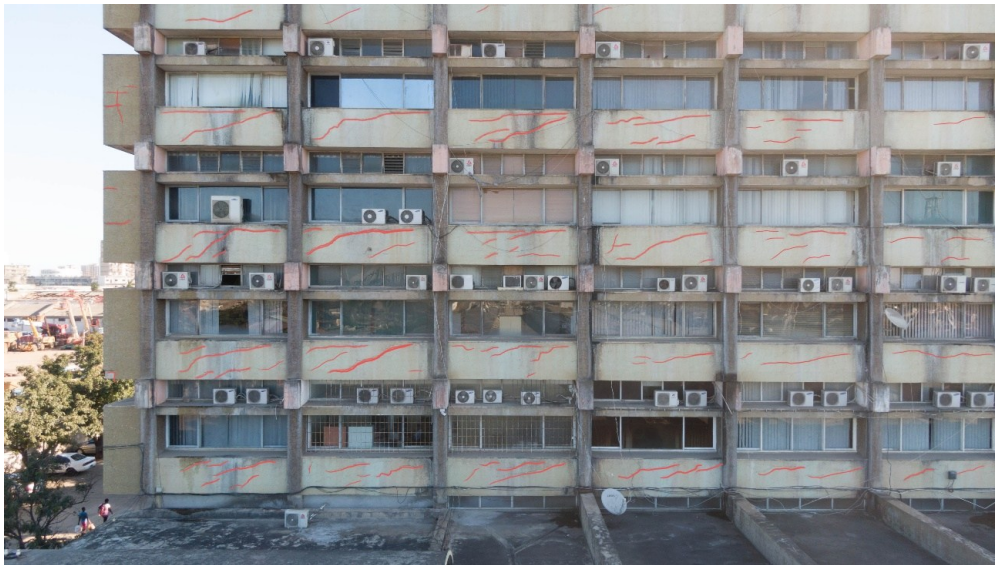
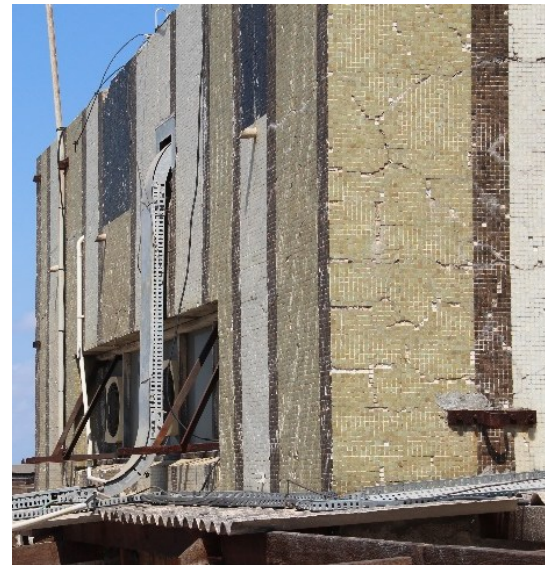
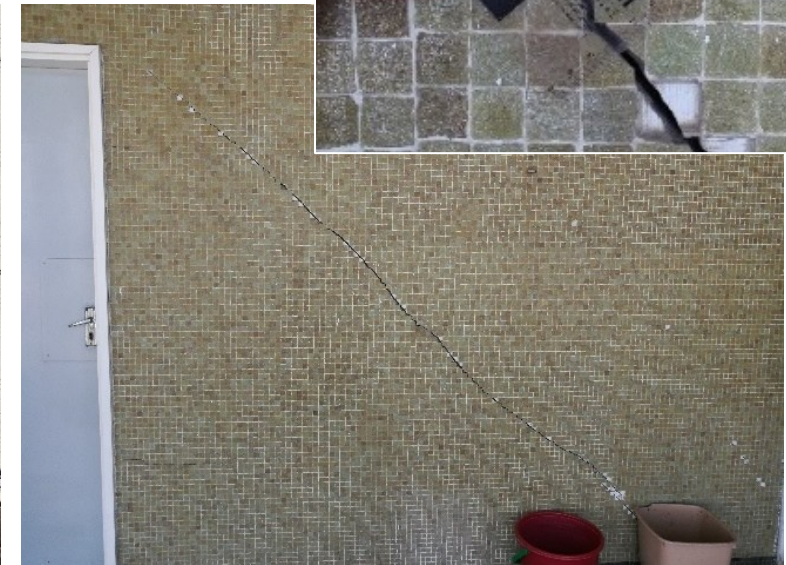
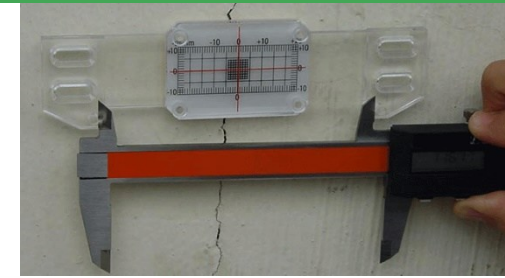
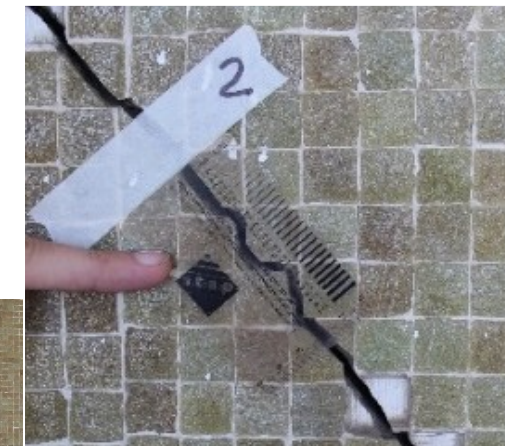
Damage survey

❑ Fair state of conservation:

- Cracks are widespread in the building, particularly in the masonry elements. Most of the exterior façade walls are severely cracked, including the exterior tiled walls of the main vertical communication core, the lateral façades and the rear façades
- Some of the cracks are being monitored since September 2019

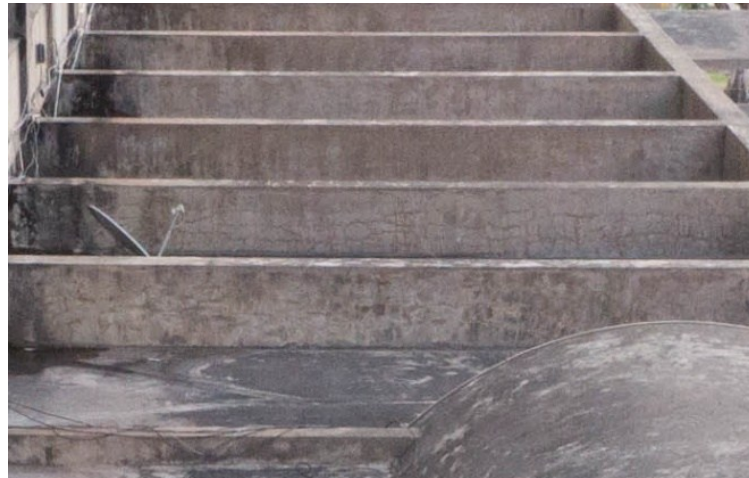
Damage survey

- Reinforced concrete structural elements are also cracked, in addition to corrosion induced cracking
- A random map crack pattern was observed together with other symptoms such as surface deposits (stains and efflorescence) and color changes, which may be an indicator of Alkali-Silica or Alkali-Aggregate Reaction of the concrete.

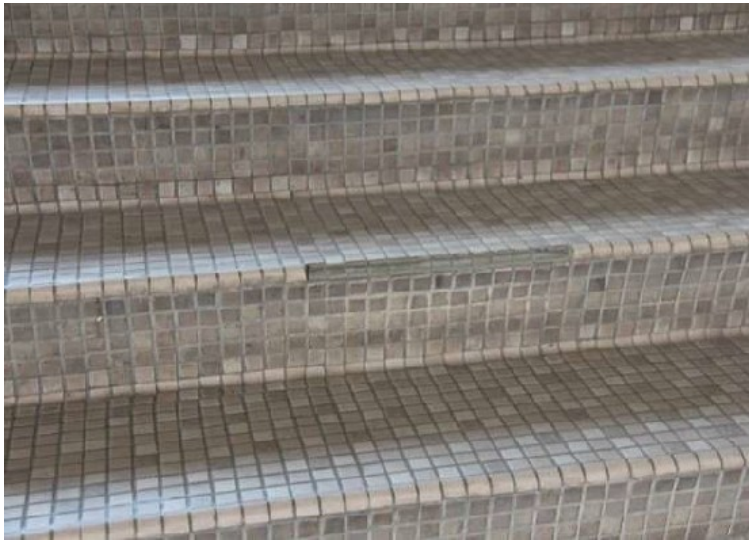
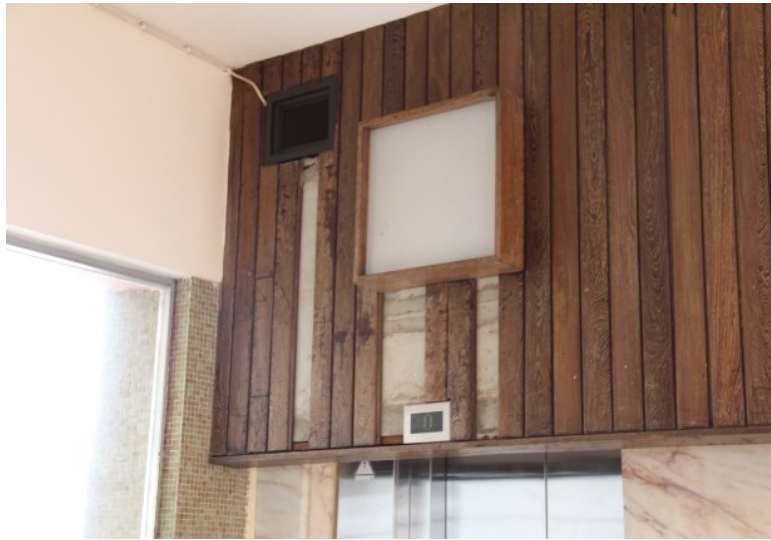
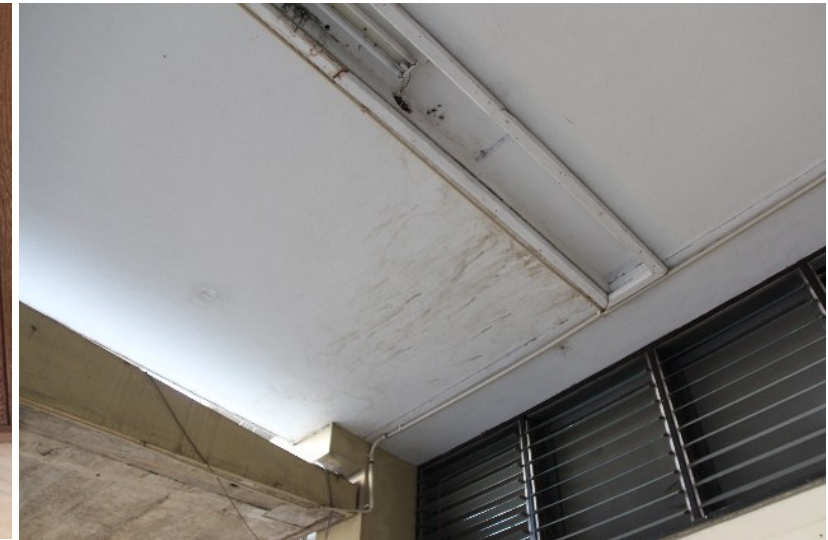
Damage survey

- General damage and low level of maintenance is observed leading to: heavy staining, efflorescence, corroded elements, broken lamps and electrical fixtures, missing and broken wooden and ceramic decorative elements, etc.
- One of the most significant damage observed of this type is the systematic loss of the small ceramic tiles used as finishing in walls, columns and interior floors.

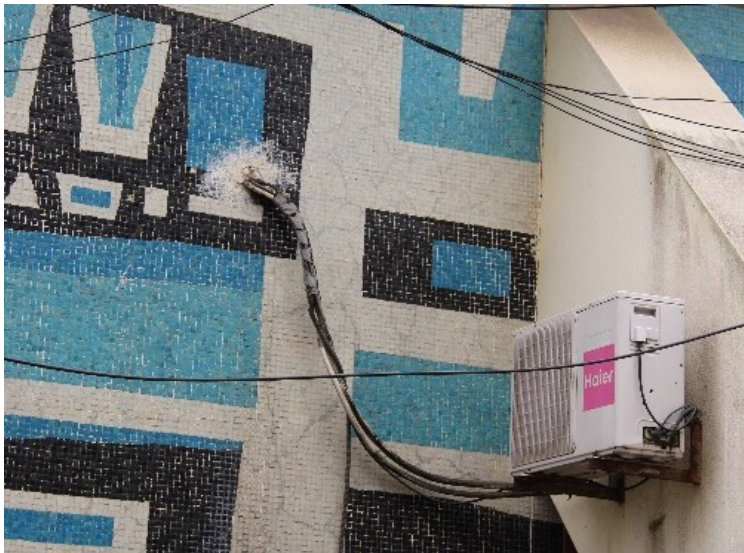
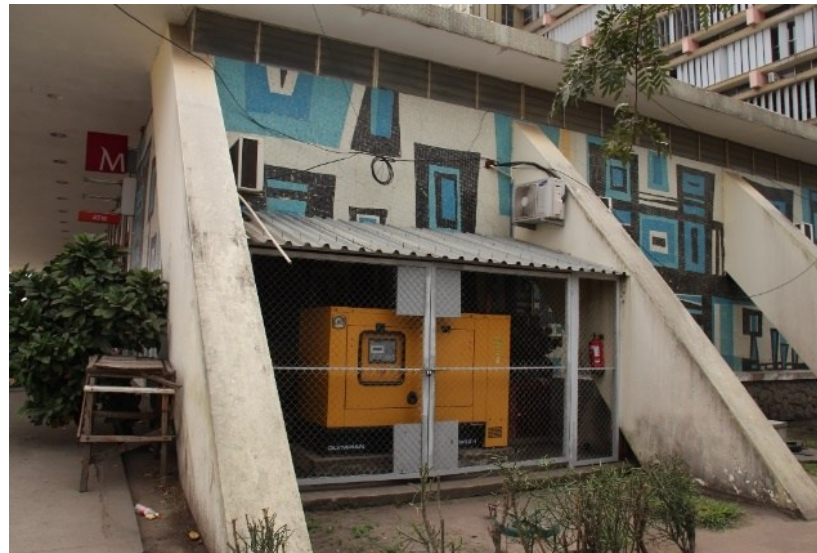
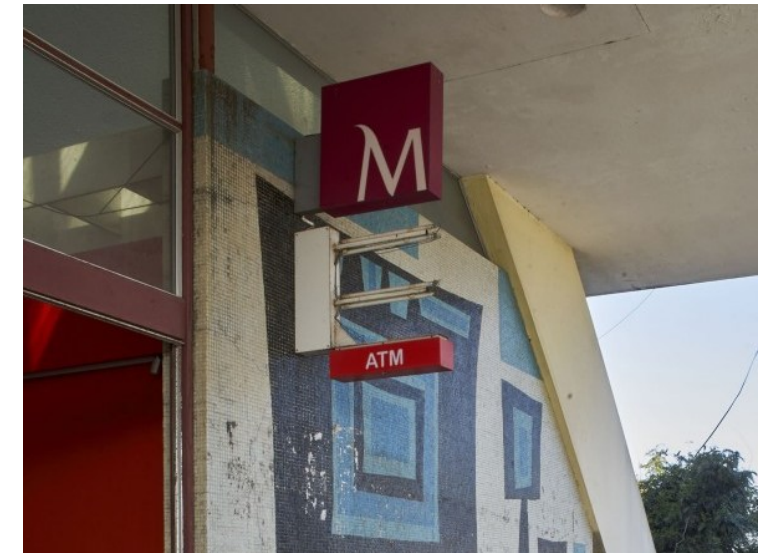
Damage survey

- Several recent interventions can be observed in the building that are detrimental from the point of view of aesthetics and authenticity: installation of new air-conditioning units, the renovation of toilets, new shopfronts in the atrium, hanging of advertisement signs, etc.

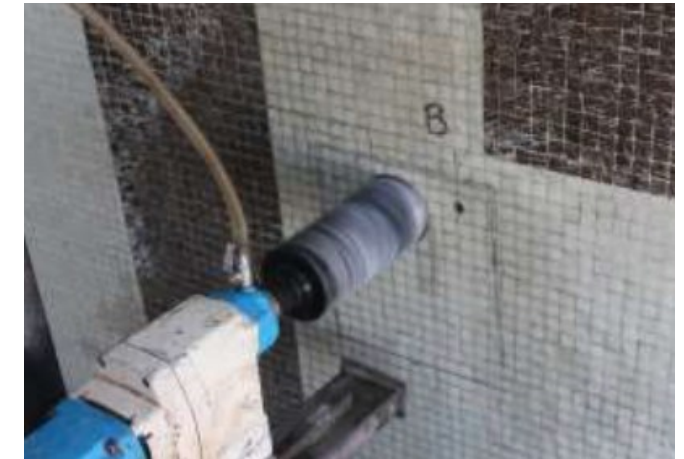
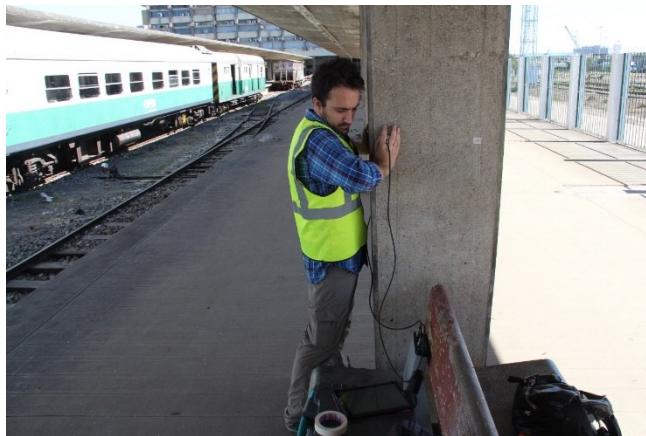
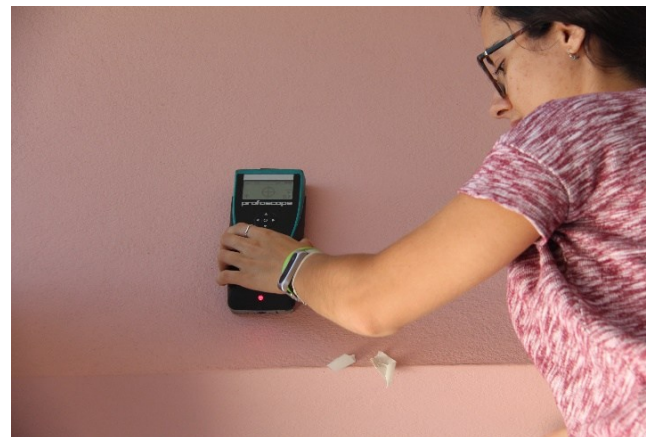
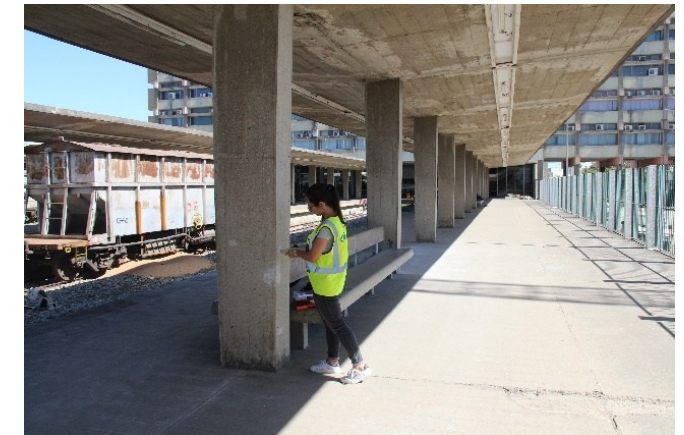
Material characterization

- Ultrasound and sclerometer
- Rebar detection
- Cores, carbonation, compressive strength and chloride / sulfate tests

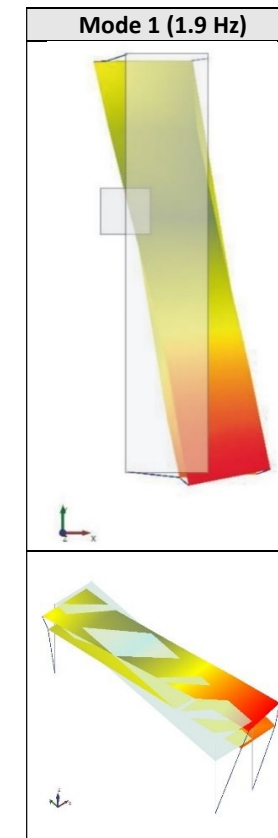
Structural assessment of the Beira Railway Station

- ❑ Numerical models to assess the structural safety of the administration building of the Beira Railway Station under different loading conditions (gravity, wind and seismic)
- ❑ Complex finite element model including all reinforcement elements of the structure and calibrated with the data from the non-destructive experimental campaign
