Conservation and management of modern historic buildings: Recent works on heritage of Portuguese origin

Paulo B. Lourenço

**Why are good technical
skills needed for existing
structures?**

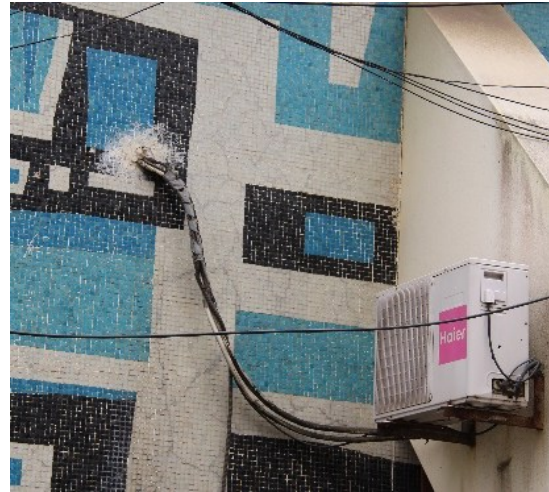
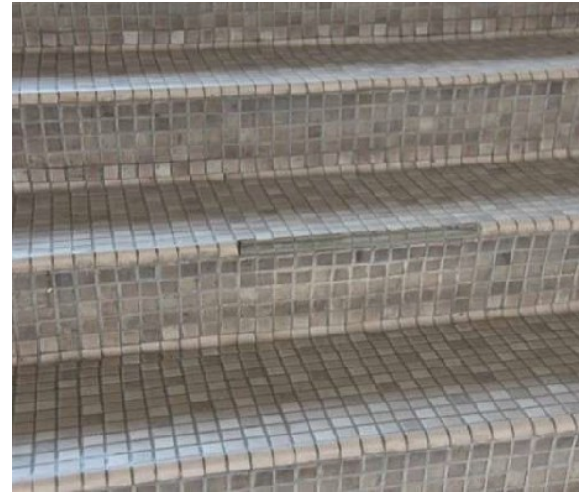
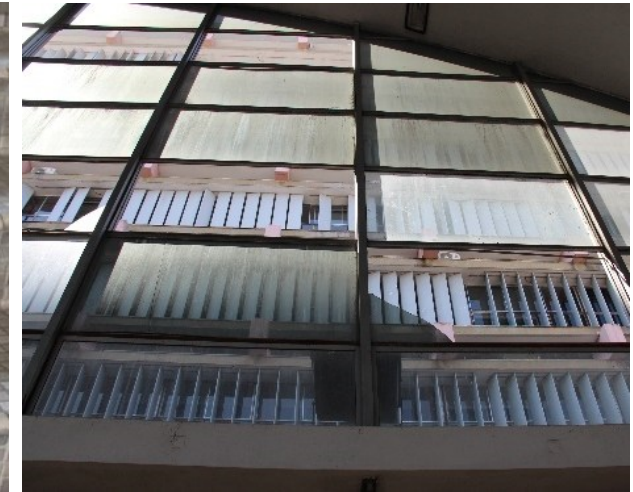
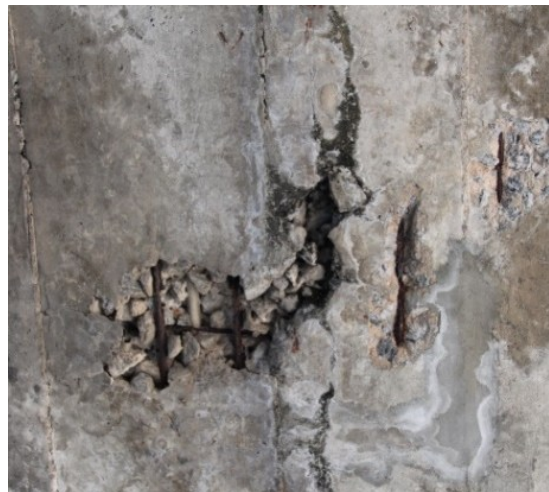
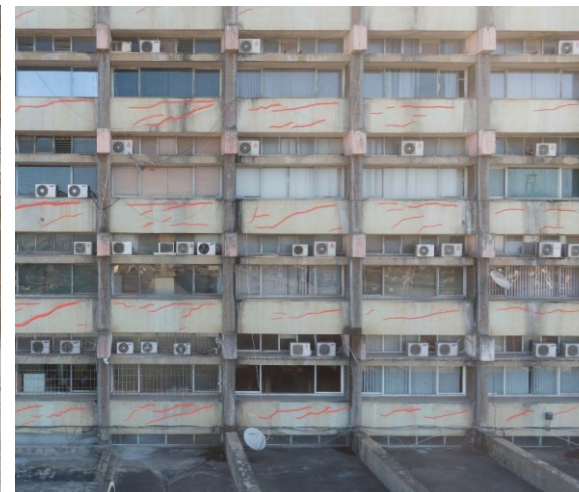
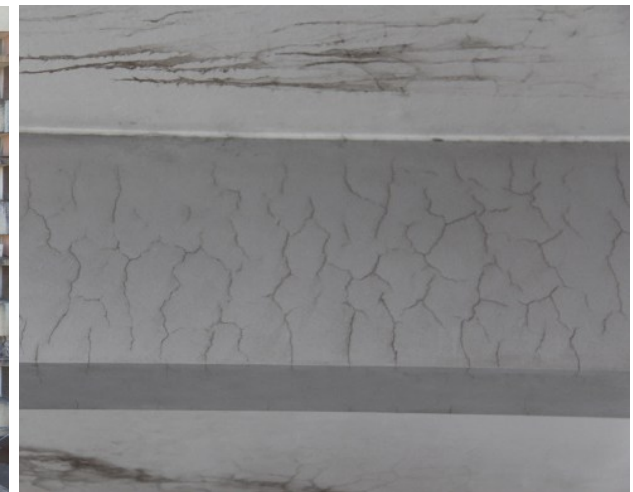
Remedial actions

- ❑ Draft guidelines for intervention: define process for each typified damage (recurrent in the building)
- ❑ Define plan of action: urgent, necessary and desirable types of actions
